EROSION STUDIES ON THE EARTH MATERIAL FROM THE SITE OF THE
PROPOSED UNLINED EMERGENCY SPILLWAY AT FOSS DAM
WASHITA PROJECT, OKLAHOMA

Hydraulic Laboratory Report No. Hyd-426

October 22, 1956

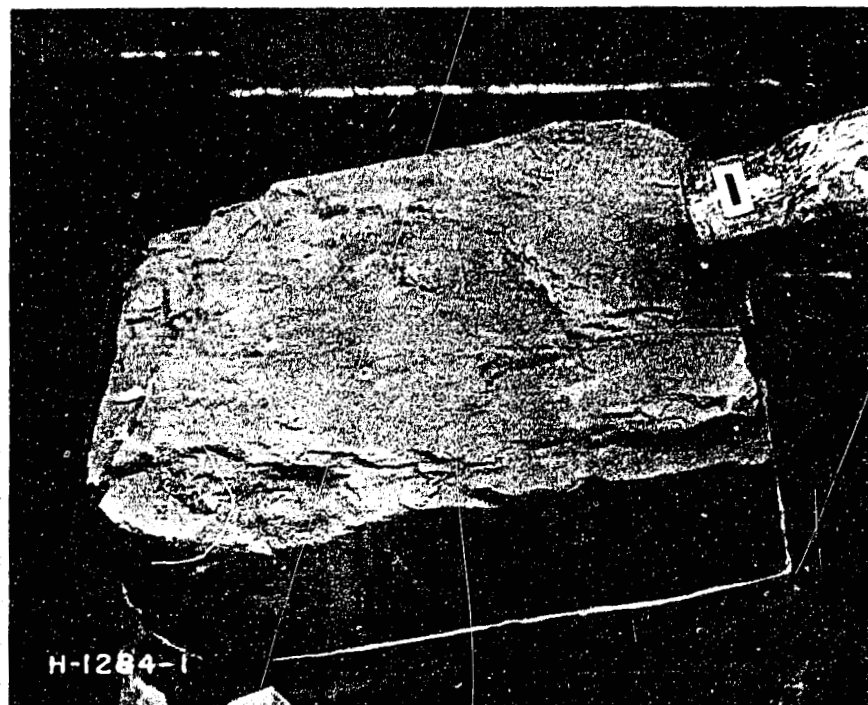
the stream of water from the 0.52- by 1.88-inch rectangular nozzle flowed over the top surface (Figure 1A). The layers within the material were generally parallel to the top surface and no special care was required as to which direction the flow passed across the block. The waterproof covering that had been placed on the sample to preserve the natural moisture content remained on the sample until just before the erosion tests were started. The test surface at the start of the tests is shown in Figure 1A.

Sample at start of test

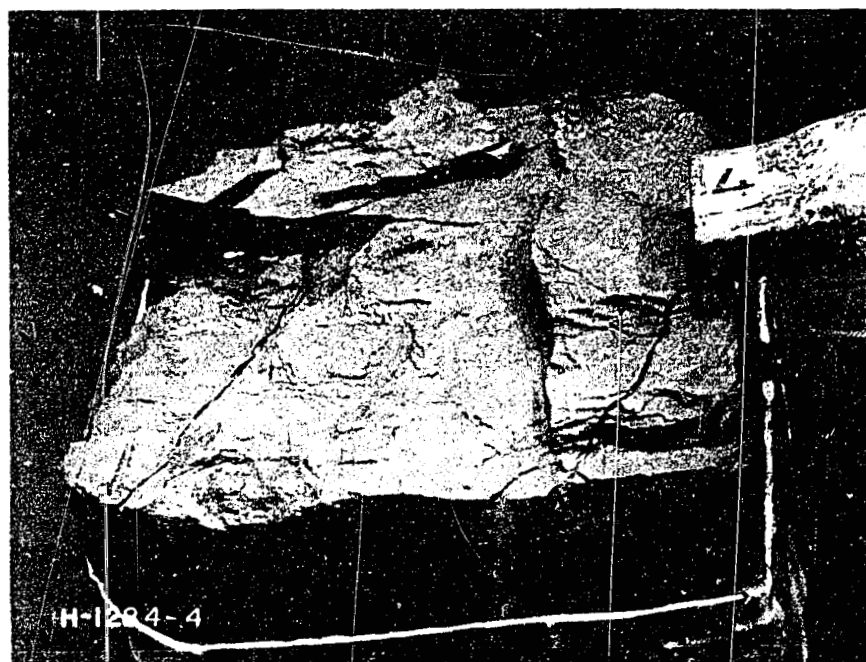
Water was first passed over the sample at a velocity of 4 feet per second and a few loose flakes and chips were swept away. No further erosion was detected during the next several minutes. The velocity was then increased to 8 feet per second, which was the approximate flow velocity for expected spillway discharges, with the result that more small flakes were carried away. Soon larger chips and slabs with thicknesses to $1/4$ inch began to break loose. When these pieces were carried away other thicker slabs loosened. After 1 hour of testing at 8 feet per second an estimated 1 inch of material had been removed from the block (Figure 1B). When accurate measurement of the depth of erosion was attempted it was found that the block had expanded greatly due to layers, which now appeared mica-like in arrangement, separating and filling with the water. When a downward force was applied to the top of the block water oozed from the material and the material compressed. Upon release of the load the material expanded to about its previous bulk.

Sample after 1 hour test with flow velocity of
8 feet per second
